Waste Tank ISI Summary

James B. Elder
Principal NDE Specialist
Savannah River National Laboratory
Materials NDE and Consultation

Tank Inspection Abstract

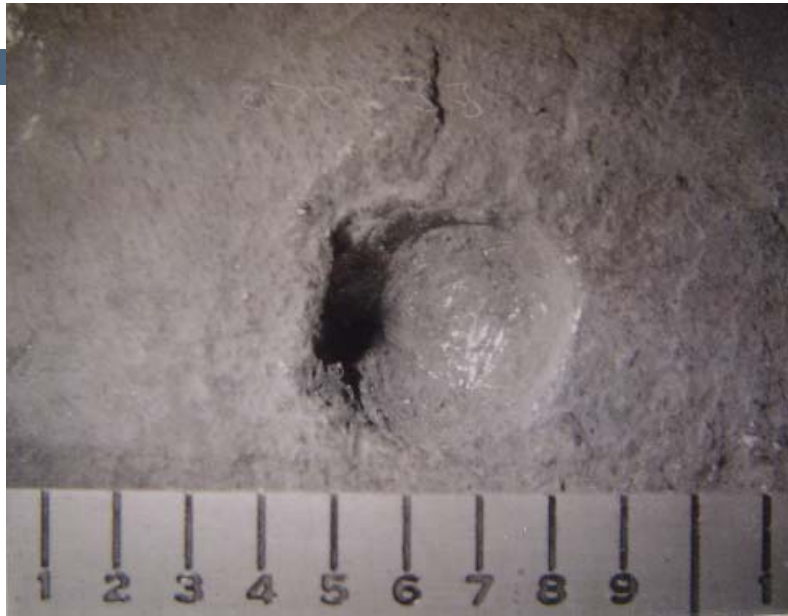
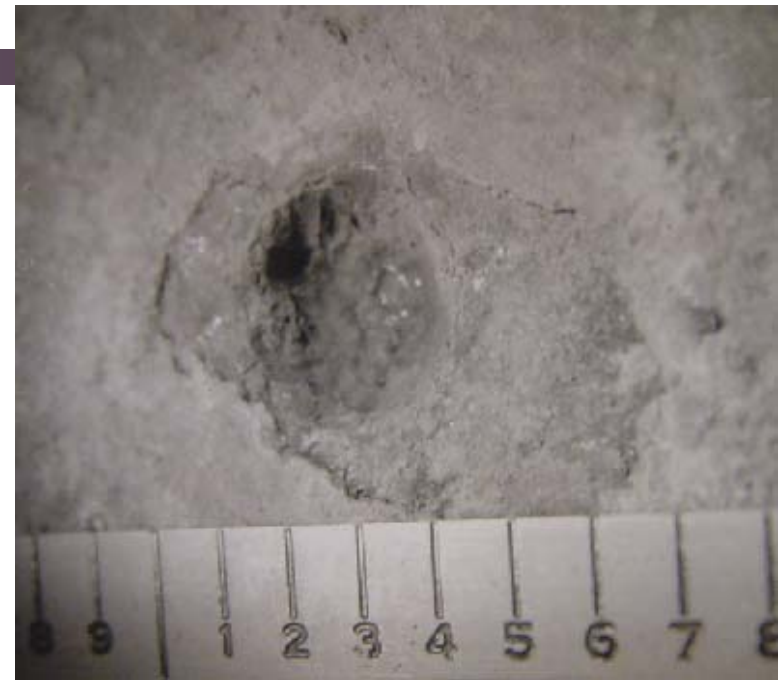
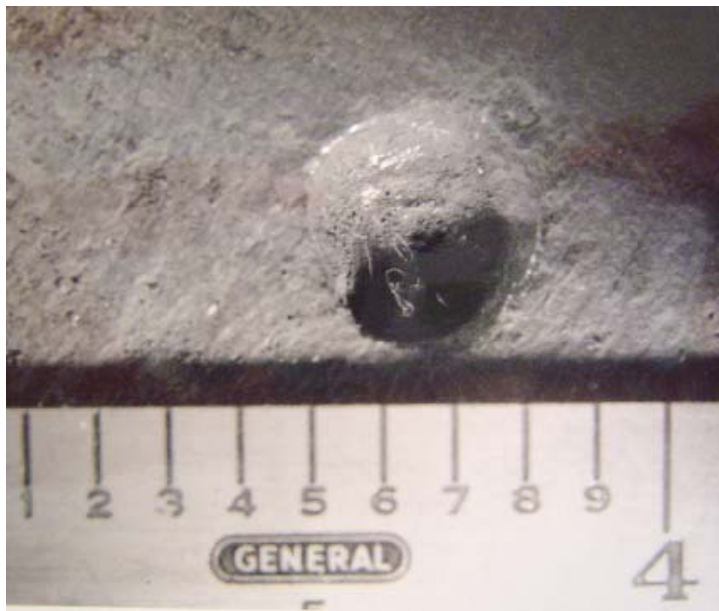
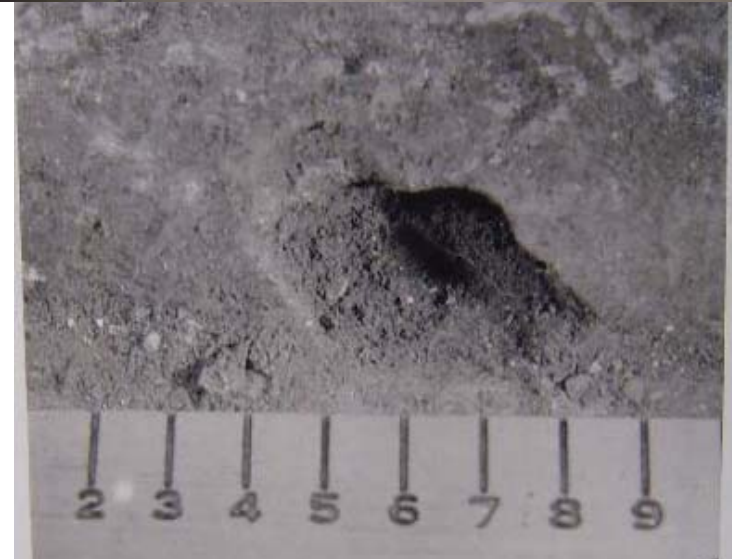
Actual Pre-Service Pit Examples (scale 0.10 inch)

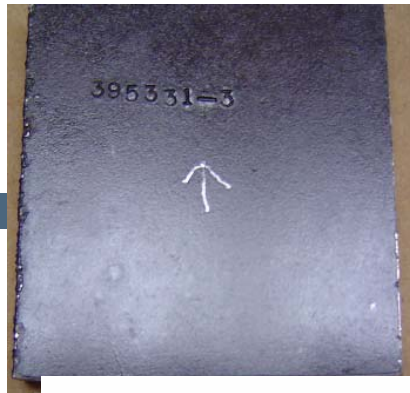
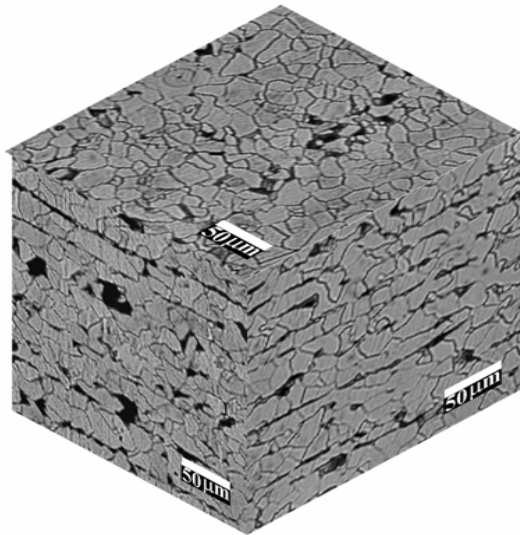
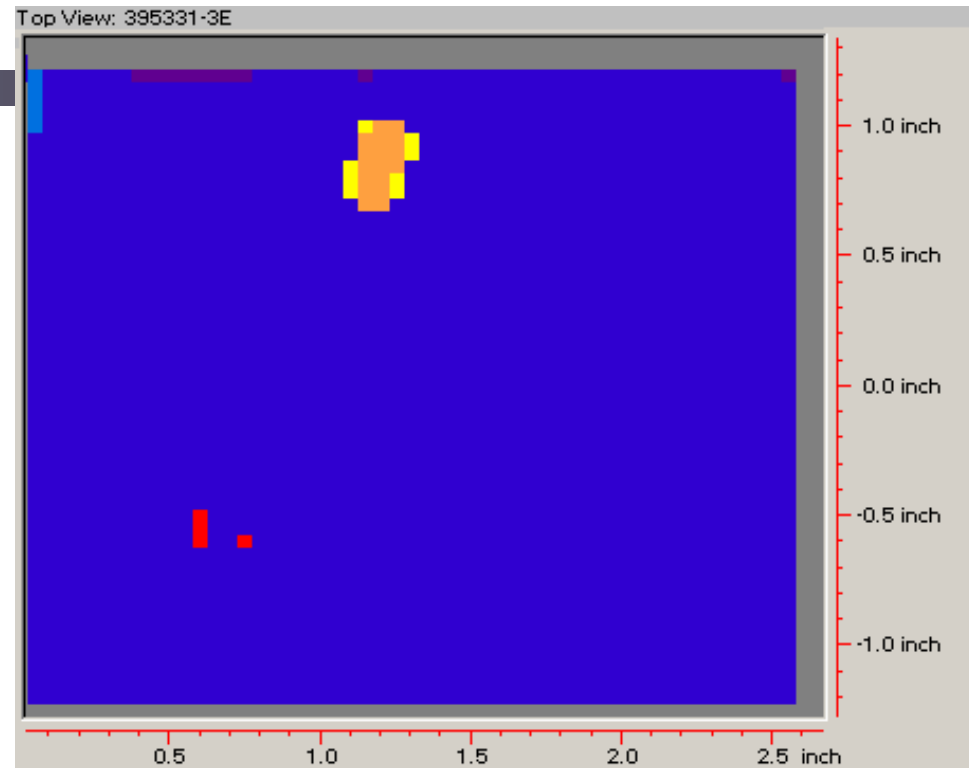
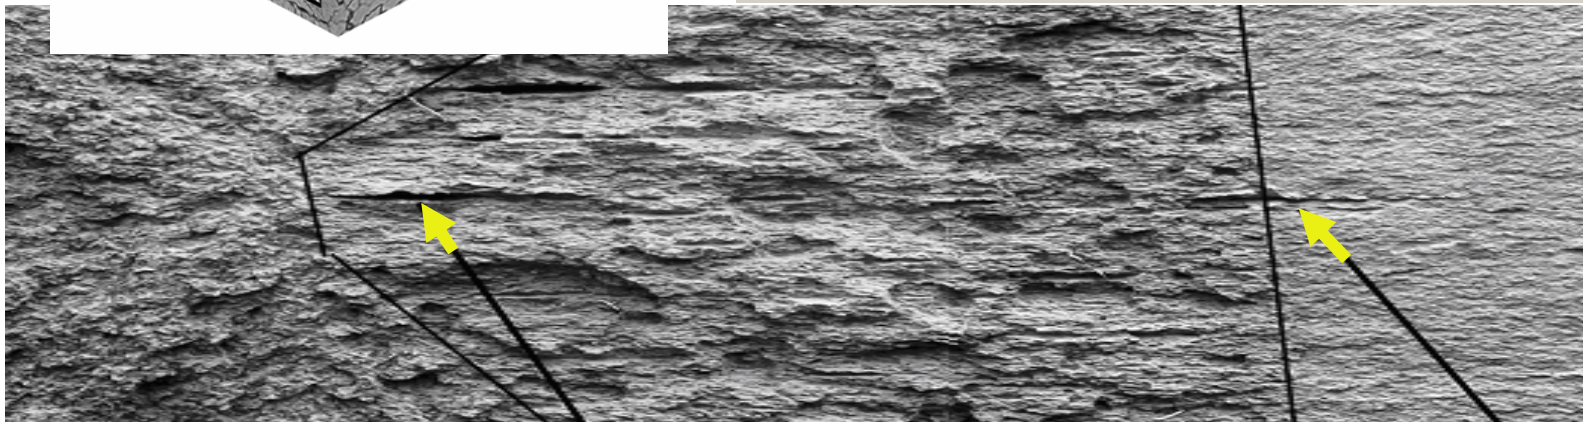
Metallographic and Ultrasonic Results Showing Impurities in Steel.

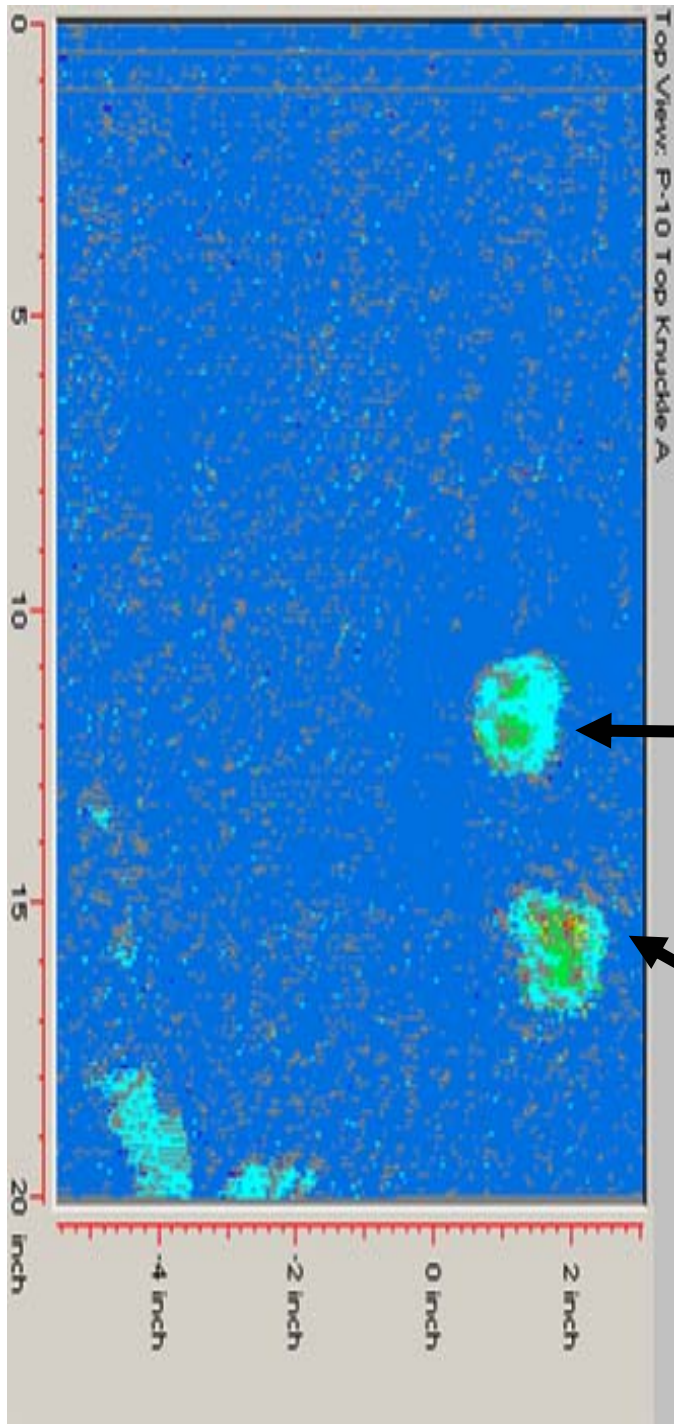
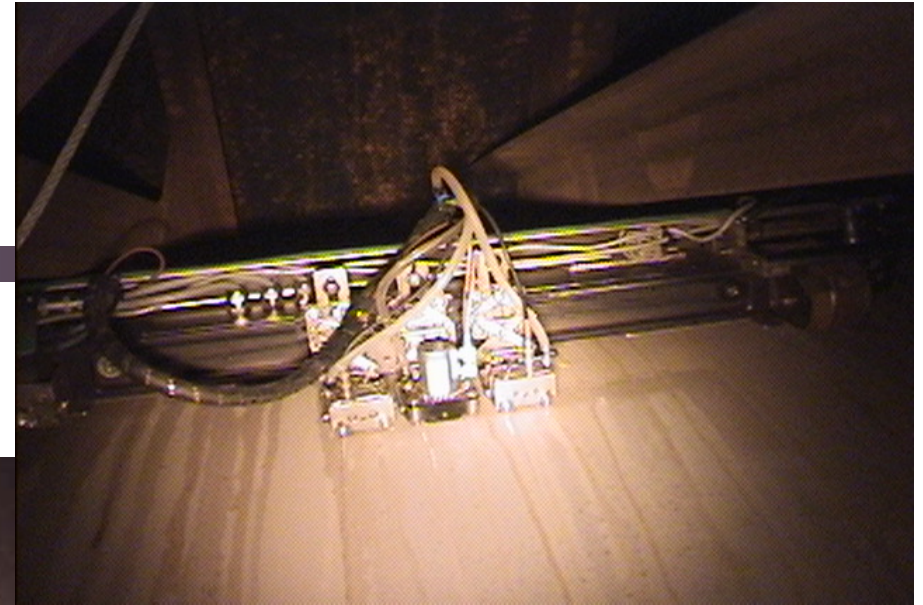
Fabrication
Artifacts – OD
Grinding areas
that were painted
over prior to
going into
service.

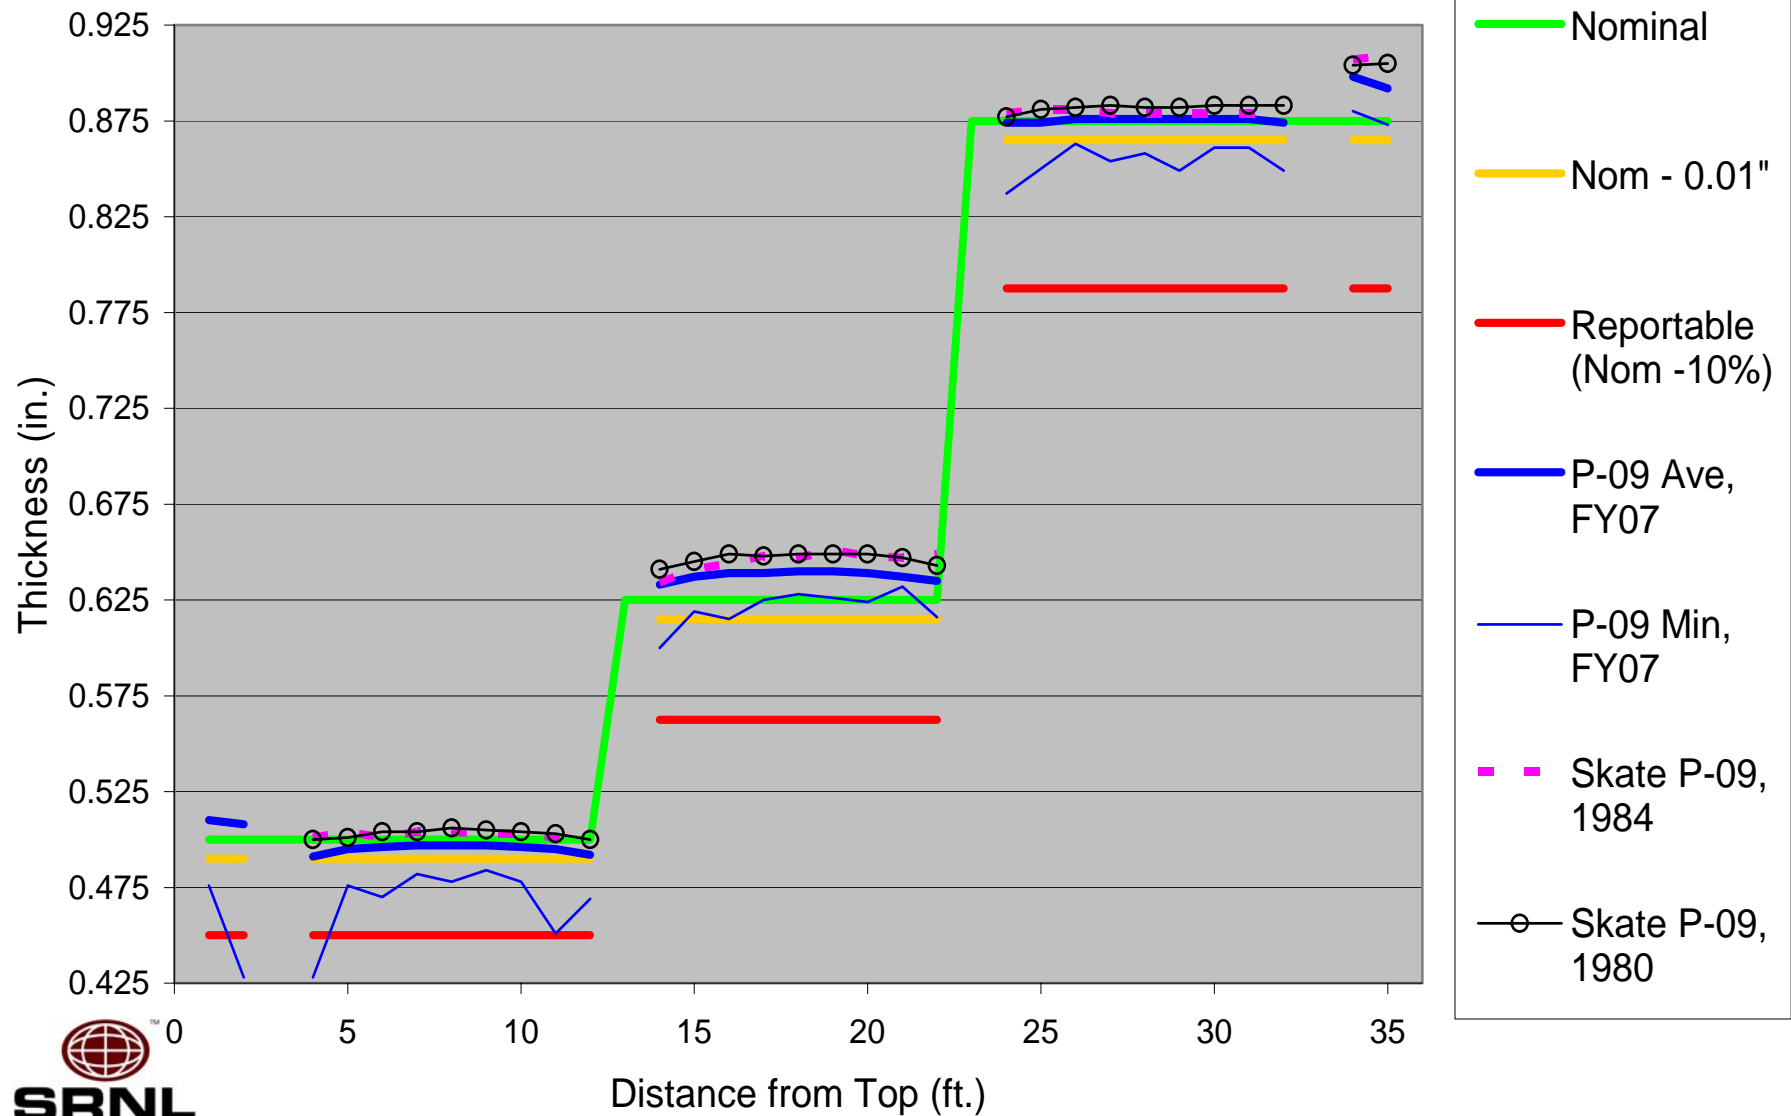
Tank 38 Riser P-09 1980 & 1984 Skate vs. FY2007

27 years of UT thickness data

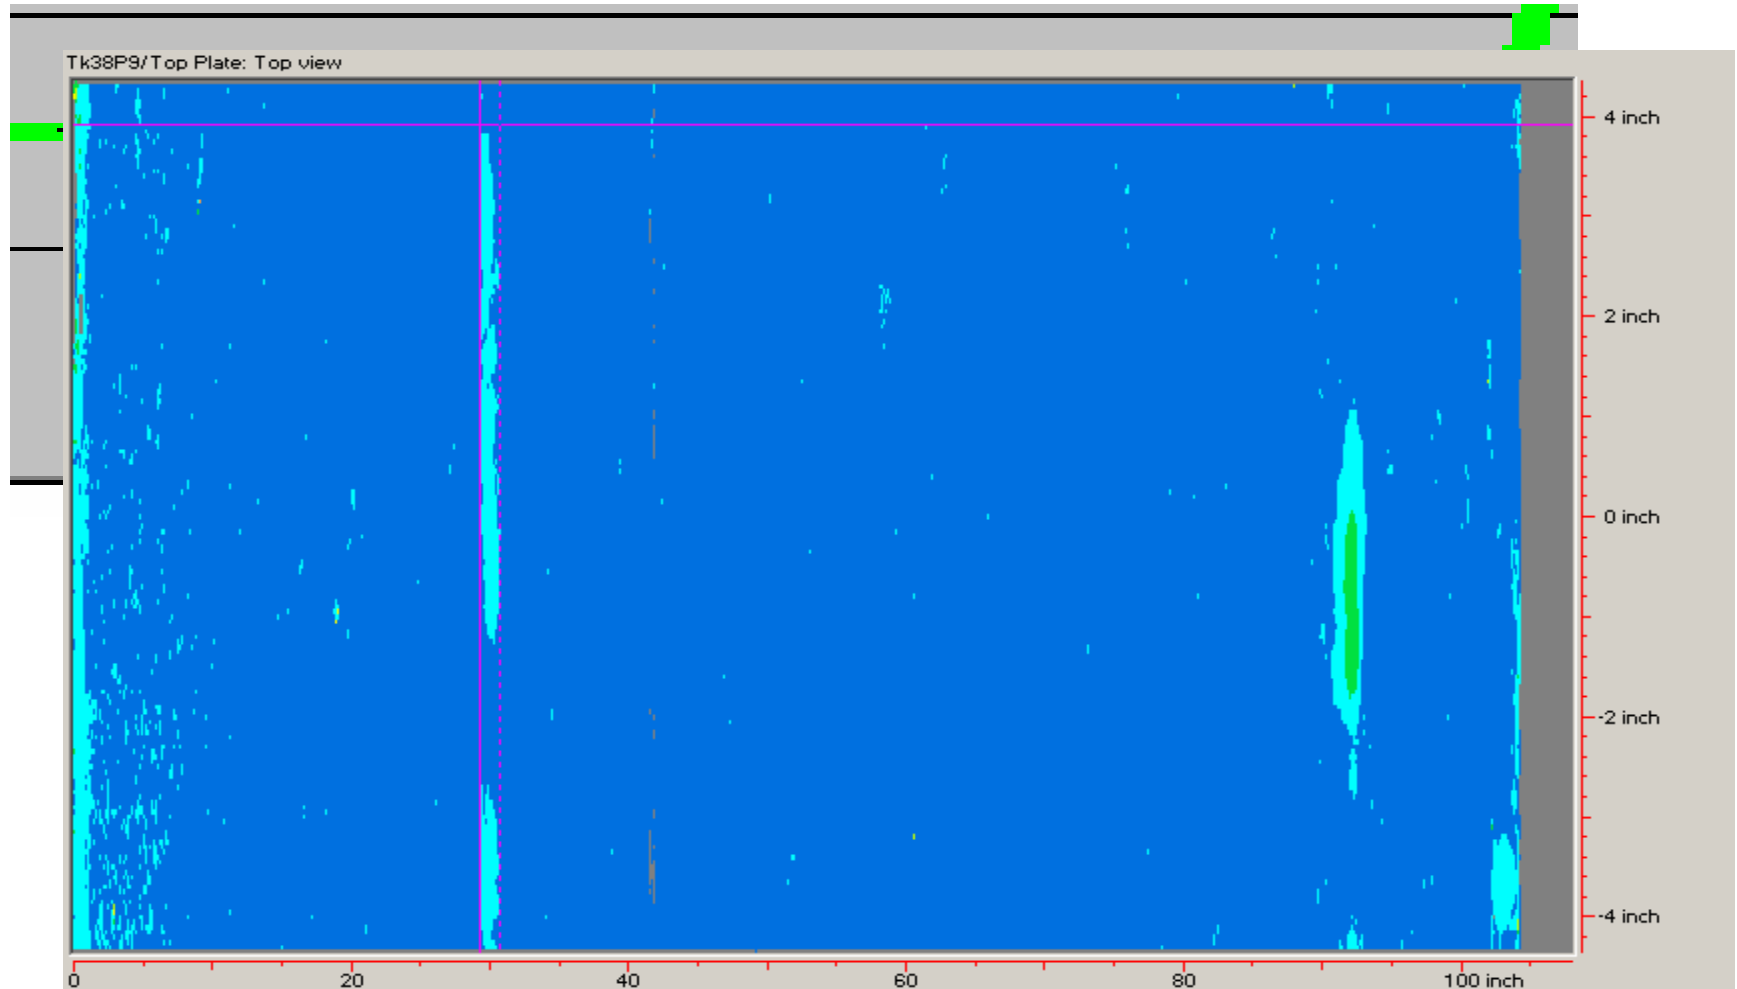
Tank 38, Riser P-9, top plate. Indications on inside surface.
Horizontal line, 30" below top knuckle weld.

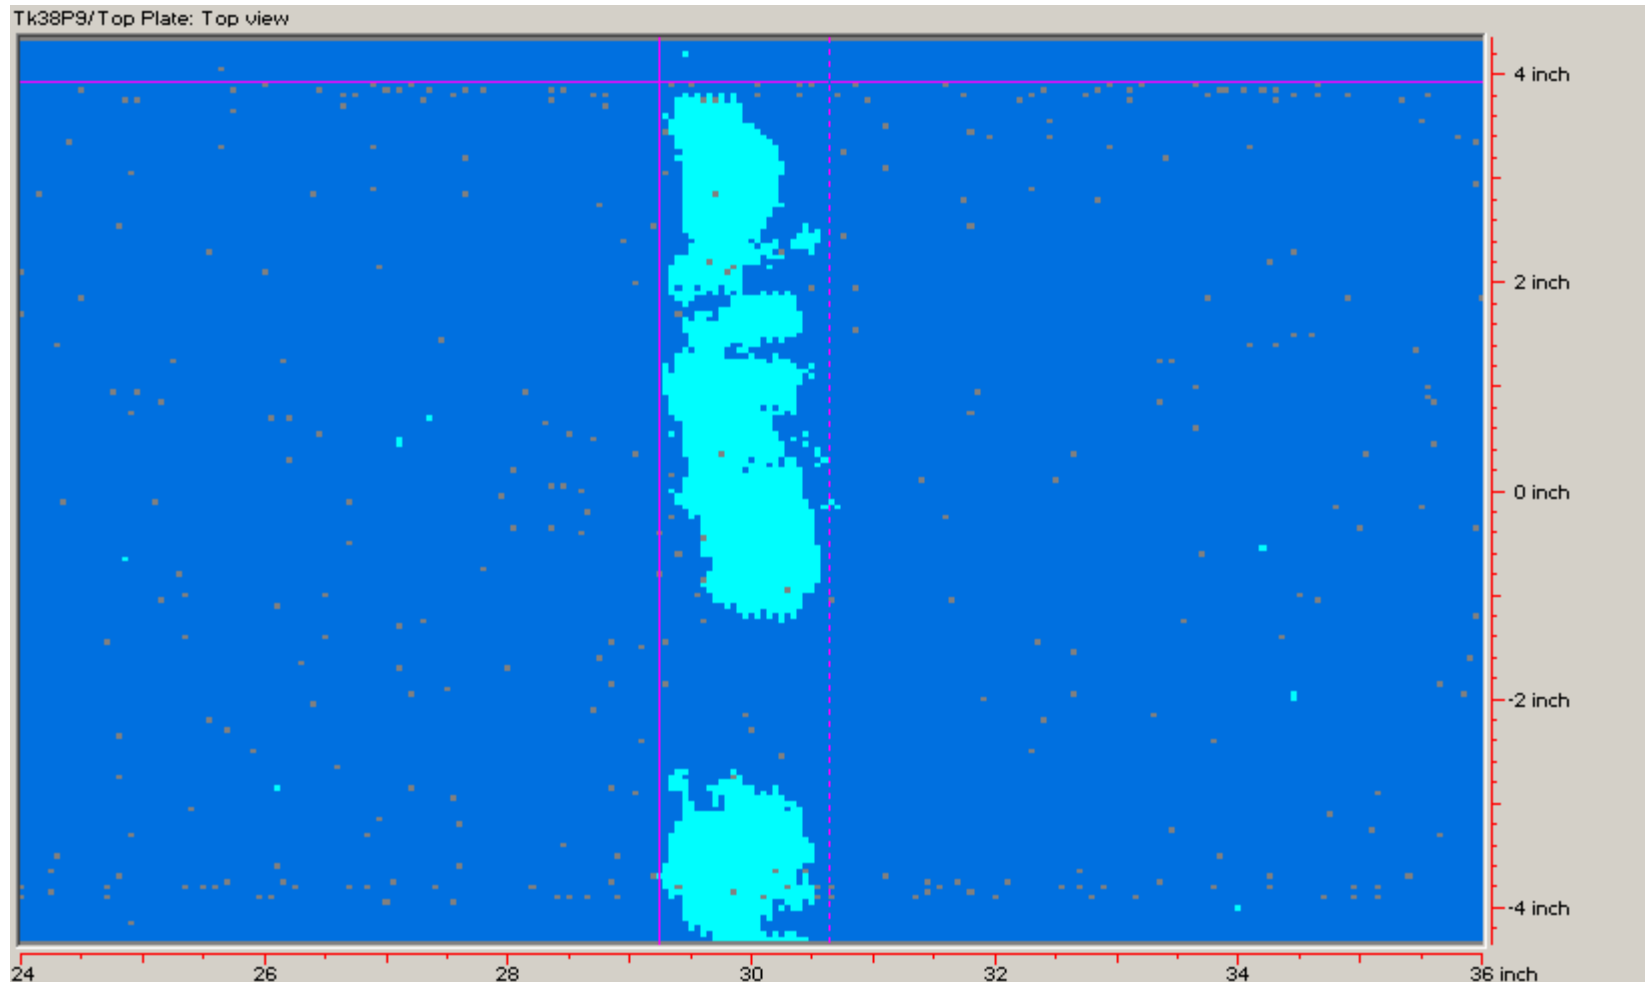
Indications on inside surface top plate Tank 38.
Horizontal line, 30" below top knuckle weld

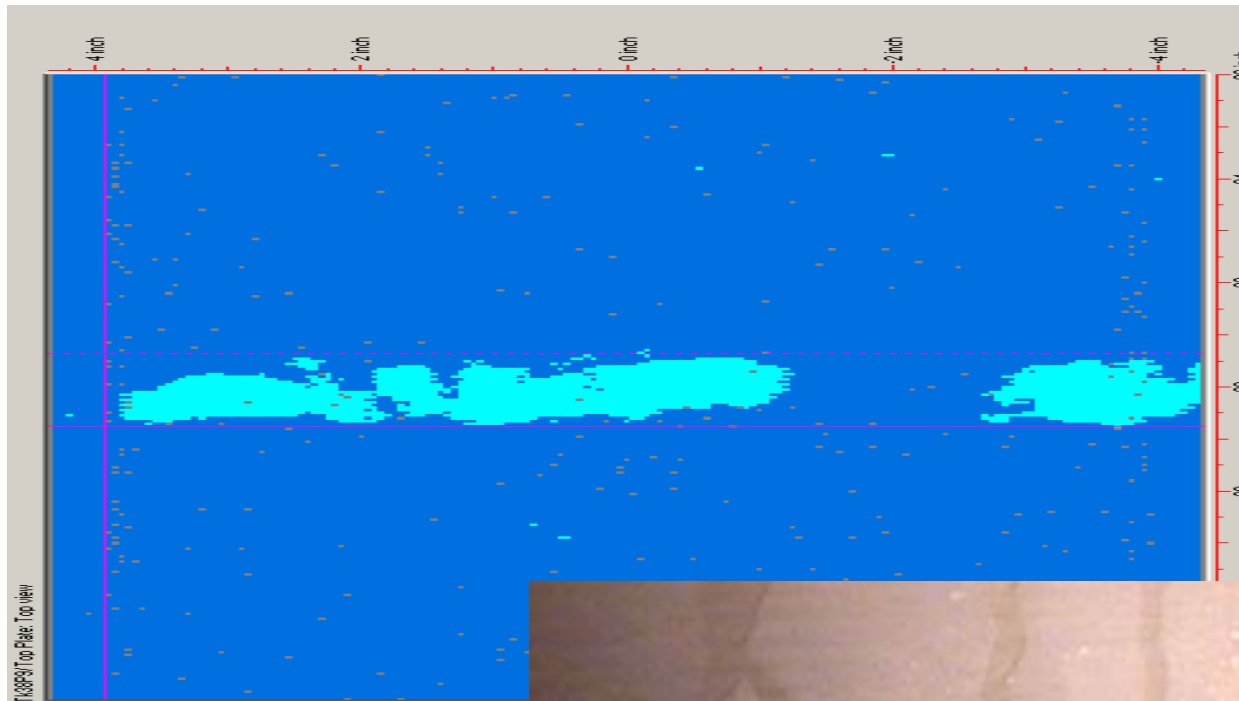
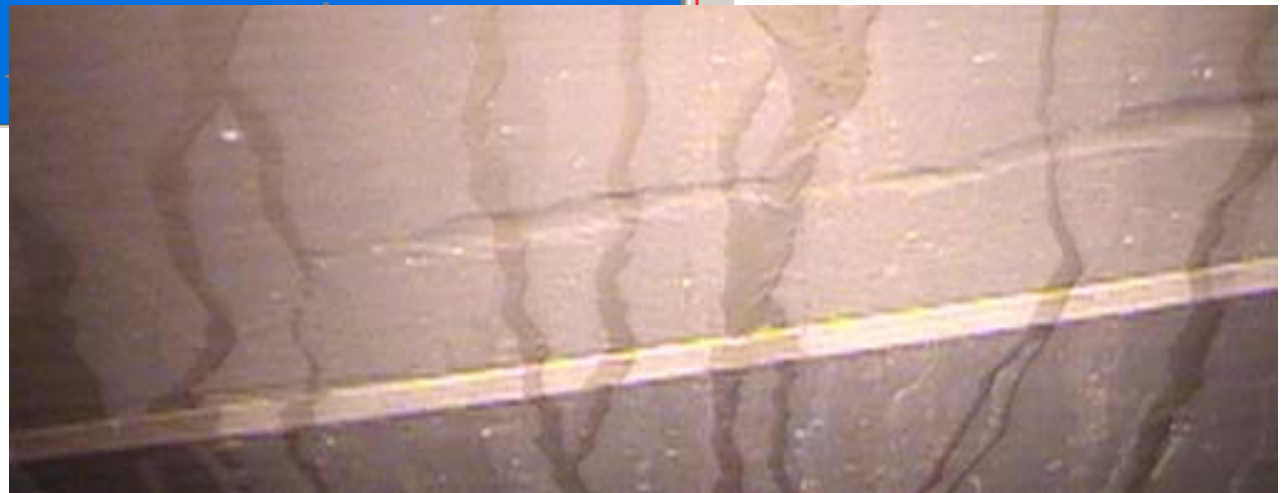
Indications on inside surface of top plate in Tank 38 are similar to fabrication artifact in top plate of Tank 41

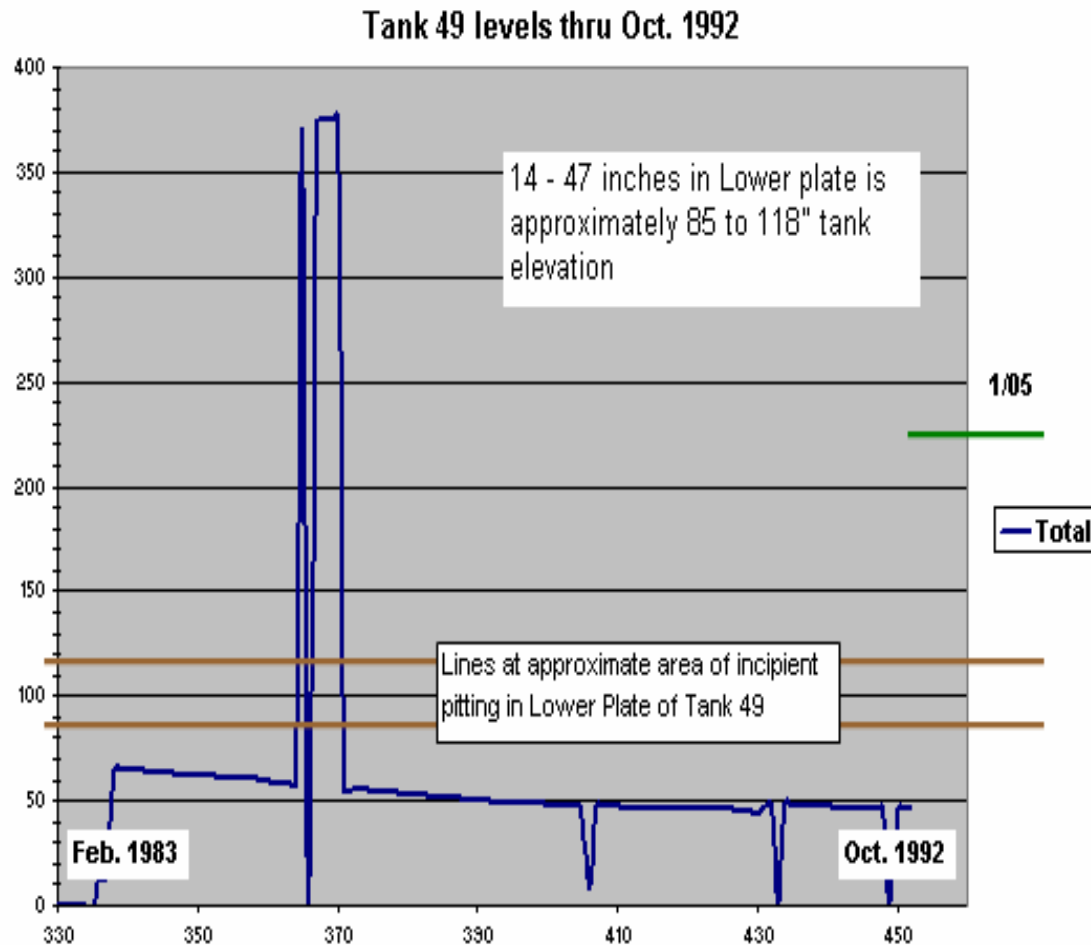
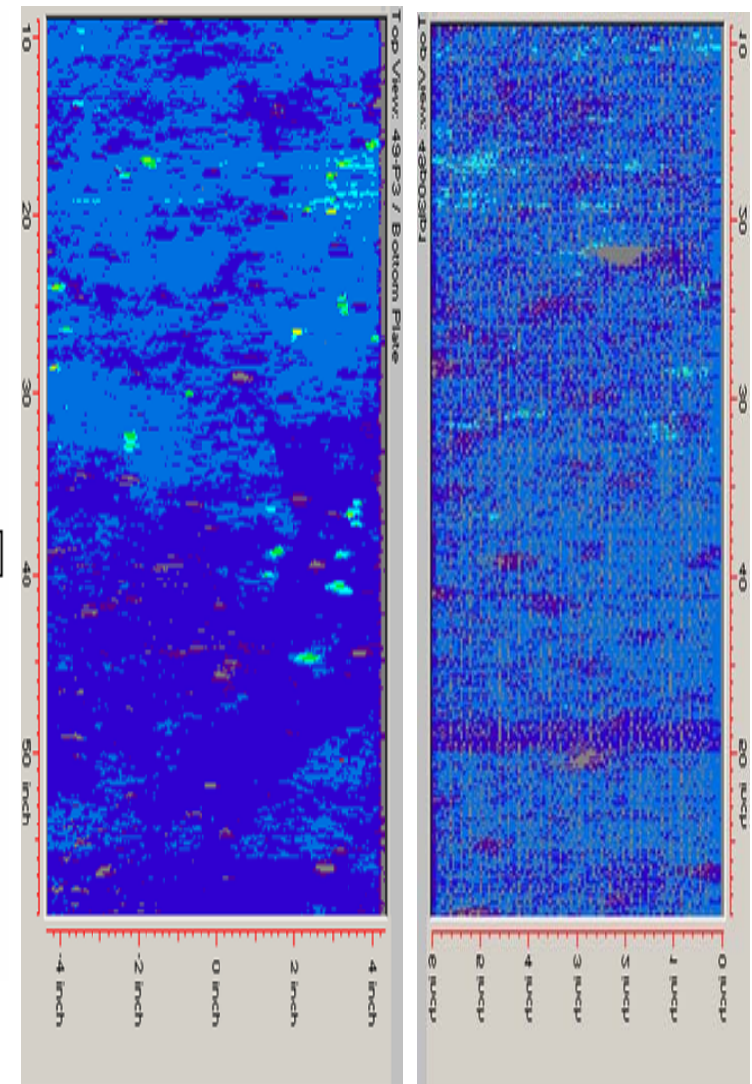
Incipient Pitting, Tank 49, Riser P-3, Lower Plate Estimated Liquid Level, P-scan Data from 1995 & 2004

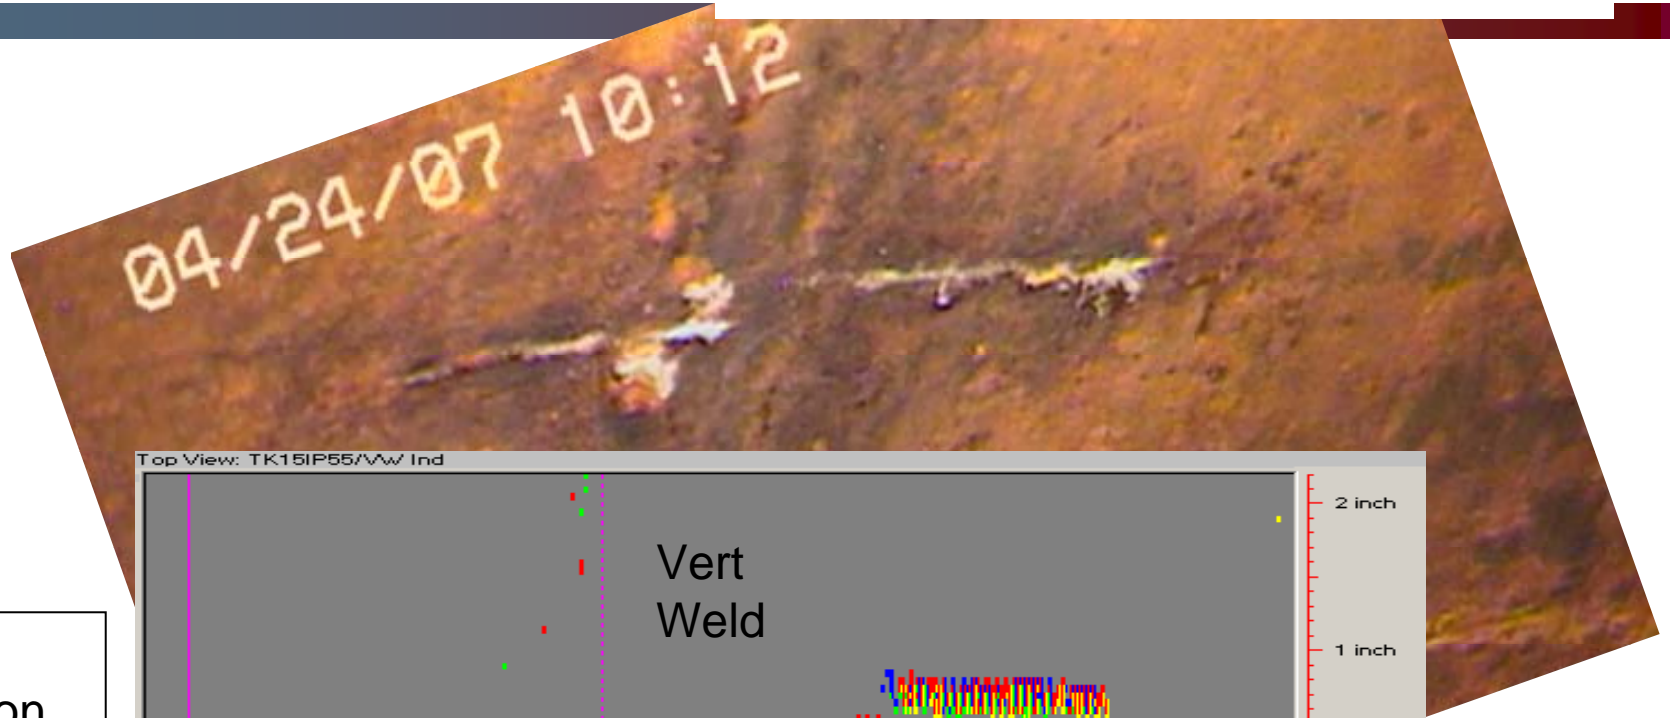
Tank 15, Vert Weld

Picture of crack area prior to scan
and data from P-scan inspection of
same area. Both from 4/24/07

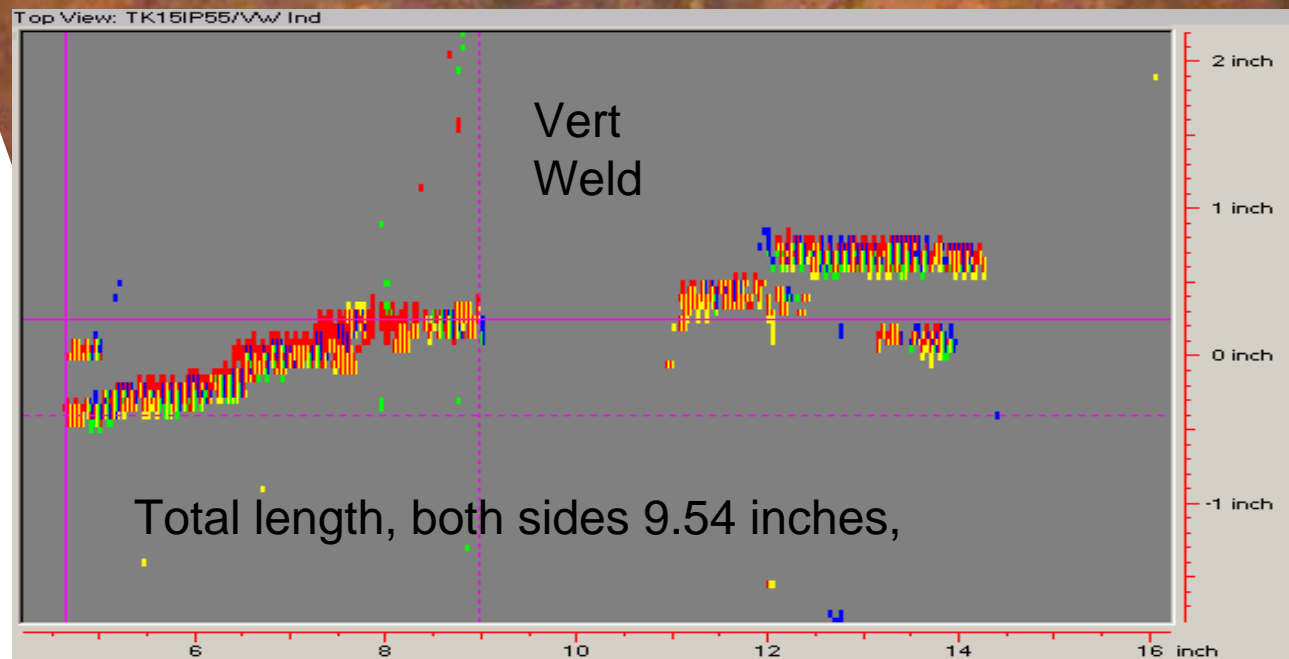
2002
Indication
number 1

Tank 15, a Type II, non-stress relieved waste tank was also inspected this fiscal year as part of the ISI program. The same examination techniques were used on Tank 15 as on the Type III tanks. Tank 15 has been out of service due to leakage from stress corrosion cracking (SCC). Inspections were performed to validate known corrosion models and determine if crack growth occurred since the previous examination five years ago. Several cracks were found to have increased in length perpendicular to the weld seam.

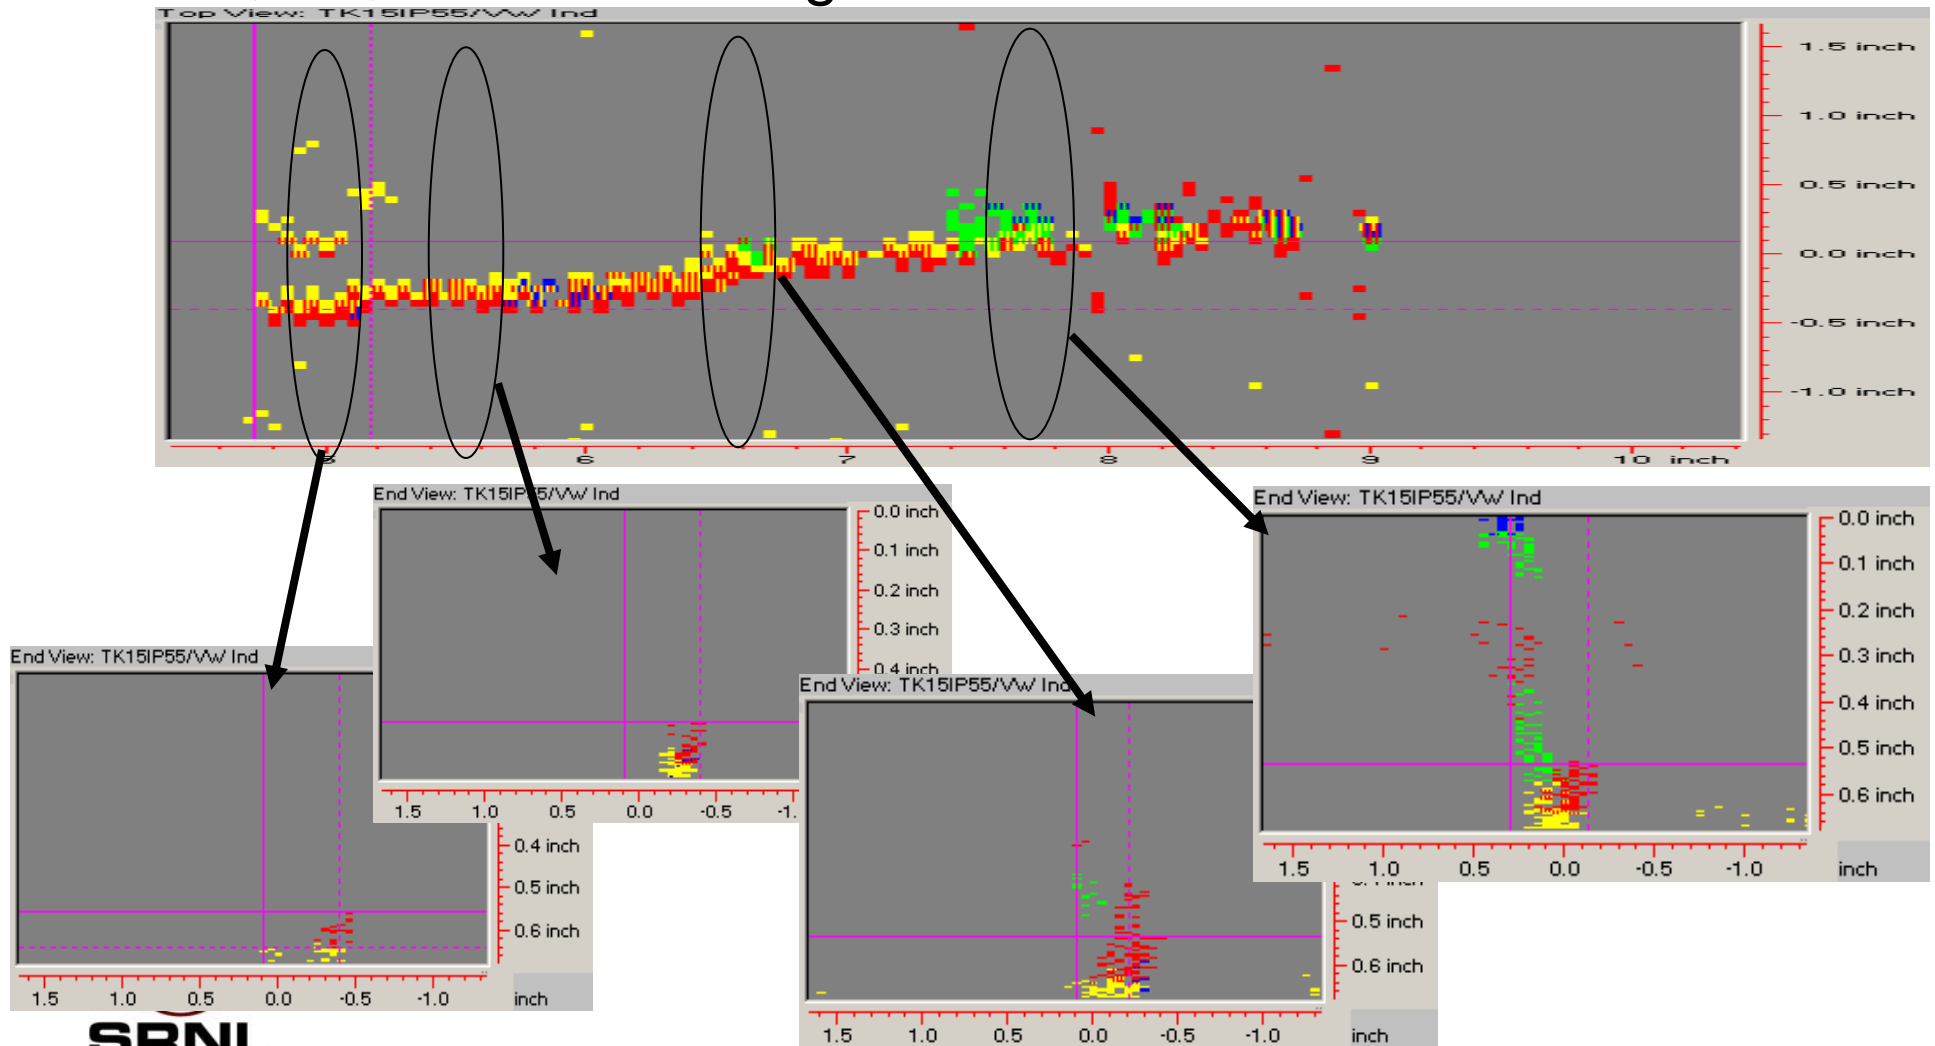
End View slices showing depth along crack

↔ Increased length 0.46"

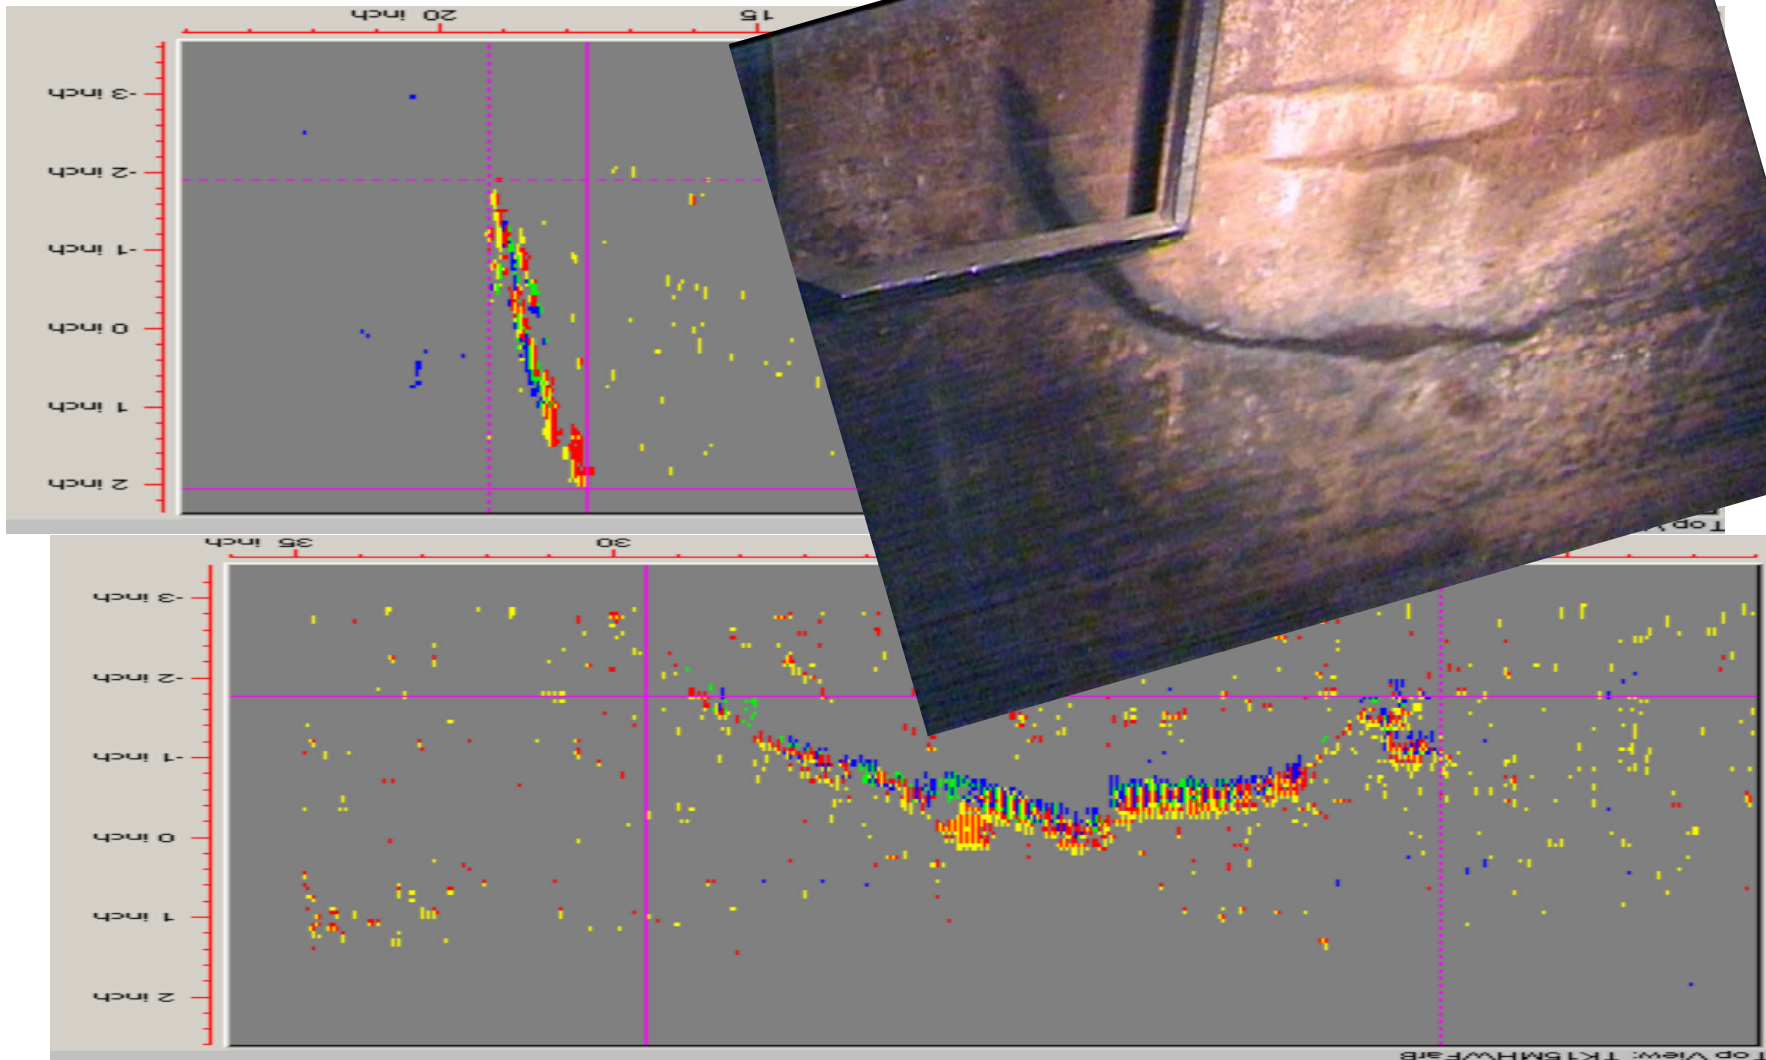
2002
Indication
number 10

Tank 15 Middle Horizontal Weld Indication at repair weld @ 207'

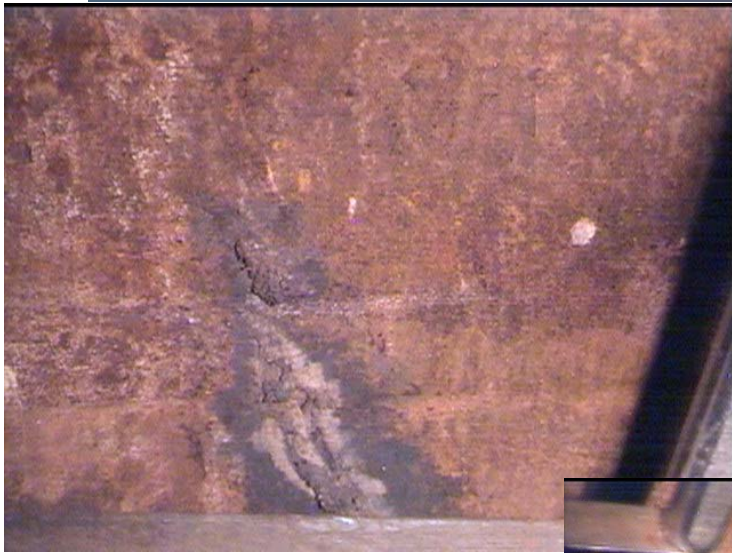
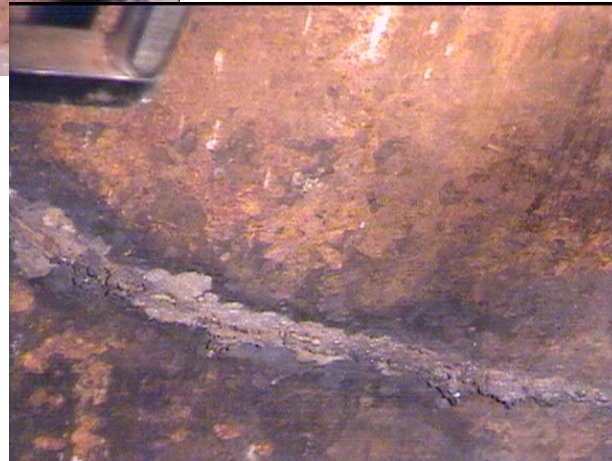
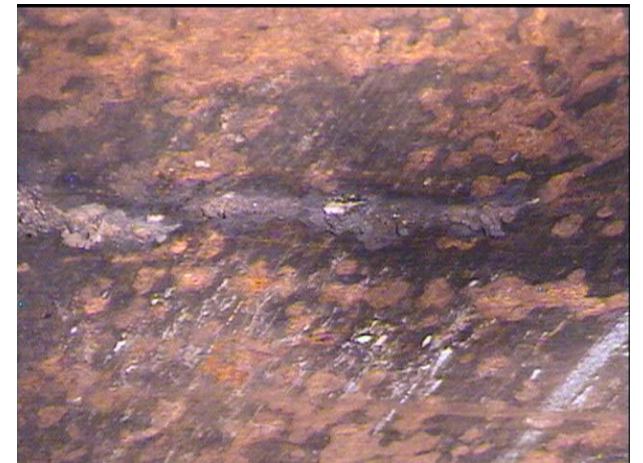
Detail of Tank 15 crack @ 207' as found in 2007
